# FAILURE ANALYSIS AND ACCIDENT INVESTIGATION ACTIVITIES AT NAL

R. Rangaraju

*Failure Analysis Group, Materials Science Division, National Aerospace Laboratories,  
Bangalore-560 017, India.*

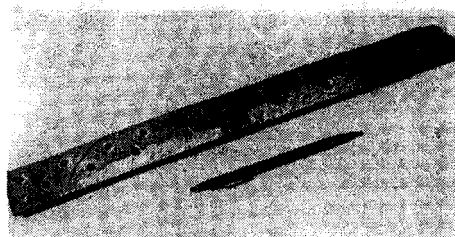
Fig. 3. Exfoliation Corrosion attack on 2024 aluminium alloy spar cap.

Fatigue failures can be of low cycle or high cycle type and can also occur under thermal or corrosive environments. Corrosion can manifest itself in several forms but from the failure analysts point of view, pitting corrosion and intergranular corrosion are of significance. Exfoliation corrosion is a special form of intergranular attack that primarily affects aluminium and magnesium alloys. It is markedly directional and is characterised by attack of the elongated grains on a plane parallel to the rolled, forged or extruded surface. This results in the characteristic delamination or destratification of the surface layers. Figure 3 shows a 2024 aluminium alloy extruded spar cap affected by exfoliation corrosion.

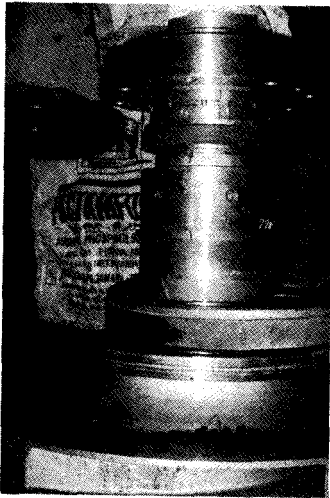
Fig. 4. Failed, motor driven pump of a fertilizer plant.

There was failure of a motor driven pump in a fertiliser plant (Fig.4). The pump failed during operation resulting in extensive damage to several components. Dismantling of the failed pump showed fracture of the shaft and extensive damage to throat bushes and sleeve nuts. Pieces of metallic debris were recovered from the non-driven end throat bush region. Observations and laboratory tests revealed that these metallic pieces had originated in-situ from the interface of the nitronic bush and the stellite inlay on the sleeve nut due to adhesive wear, that is, constant rubbing of the rotating sleeve nut with the stationary throat bushing. The loose particles thus generated had choked the clearances and caused frictional heat and ultimate seizure leading to fracture of the shaft and other damages observed. Insufficient clearance between the throat bush and the sleeve nut was identified as the cause for the adhesive wear.

Specification gave a clearance on diameter as 0.8 mm. It was suggested that it would be advisable to specify the minimum clearance in static condition at the bottom side of the shaft. It was also suggested to take into consideration the possibility of shaft deflection while running. Based on these recommendations a design review was undertaken and the problem was overcome by providing the necessary clearances.

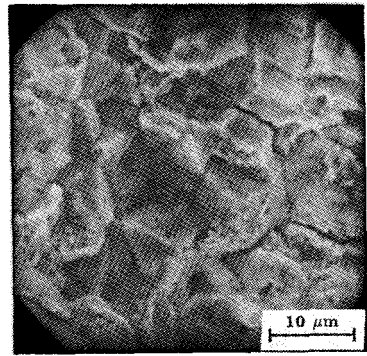
Fig. 5. Intergranular features, typical of hydrogen embrittlement, seen on the fracture surface of the failed screw.

screws had failed at the assembly stage. Laboratory investigations revealed that the cracks had originated at thread roots and progressed inwards. Gross fracture features were typical of brittle failure. Under the scanning electron microscope intergranular fracture mode with partially formed dimples on the fracture facets was observed (Fig.5). The hardness of the screw was measured and found to correspond to 43-45 HRC as against the specified hardness of 33-39 HRC.

Fractographic features clearly indicate hydrogen embrittlement as the cause of failure of the screws. Hydrogen embrittlement is a common problem in high strength steels that are plated for corrosion resistance. Hydrogen enters the steel during plating and/or during pickling prior to plating and embrittles the steel leading to its cracking during service. Higher hardness (strength) increases the materials susceptibility to embrittlement. A baking treatment immediately after plating, as per recommended standards, will avert this problem.

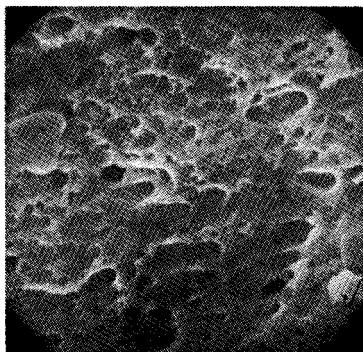
Fig. 6. Elongated shear dimples typical of torsional overload seen on the fracture surface of the failed link.

An Aileron control linkage of a pilot less target aircraft (PTA), made of steel, failed during test and assembly. The control link had failed at a thread root. Spiral like deformation marks and shear dimples on the fracture surface (Fig.6) confirmed torsional overload as the cause of failure. At the region where the linkage was bolted, one of the threads was wrenched and pulled out indicating excessive torque. This is a case of failure due to improper tightening. The use of proper torque wrenches and exercise of care to see that the linkage is not over-torqued is an obvious solution to this problem. It was also suggested that the diameter of the threaded ends be increased. This will go a long way in overcoming failure.

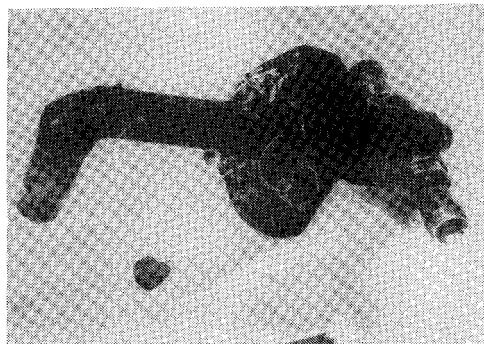
Fig. 7. The burnt fuel nozzle.

During a test flight of a four engine aircraft, warning signal for fire on one of the engines appeared. Following the failure of on board fire fighting exercises, the aircraft made a safe three - engine landing. However, the fire warning remained on till the aircraft power was switched off. Strip examination of the engine revealed burning of hoses and rubber gaskets. On re-start of the engine after rectifying these defects, it was observed that fuel was leaking extensively from the base of main fuel burner. It was found that the burner was fitted facing the compressor end and not the turbine end. Such a fitting can stabilize a flame around the nozzle. Fig 7 shows the damaged nozzle of the burner fitted facing the compressor end. The nozzle had been exposed to flame both at the flange end and the atomizer end. At the atomizer end, the nozzle had melted and solidified. Detailed

metallurgical investigations revealed that the steel nozzle had experienced high temperature of the order of melting point of steel. Though this is a case of wrong assembly of the burner, it also points to inadequate design since human error can inadvertently lead to a wrong fitment of the burner.

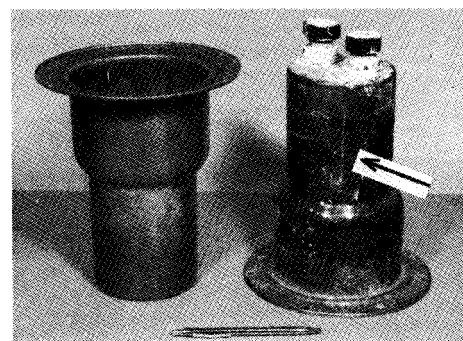
**Visual:** Fig 10 shows the two cracked luminaires brought for investigation. Arrow indicates the crack seen on the body of one of these luminaires. Cracks were seen on the body of both the luminaires and the metal was found bulged outward in the region of cracking.

Fig. 10. The two cracked luminaires received for investigation. Note the crack indicated by an arrow.

and observed in an optical microscope. The crack path was intergranular with significant branching. The microstructure was typical of cold worked, single-phase brass.

**Scanning Electron Microscopy:** Under the scanning electron microscope cleavage like features with grain boundary cracking was seen. The material was semi-quantitatively analysed by EDAX and found to conform to specifications.

**Discussion :** The nature of cracking seen in the material is typical of stress corrosion cracking. Stress corrosion cracking is common

in brass components and is familiarly called season cracking in brasses. For season cracking to occur, three conditions are necessary. (1) A susceptible material, (2) Corrosive environment and (3) Presence of tensile stress (Residual and/or applied) above some threshold value. In the present case it is seen that the material is in a cold worked state as indicated by the elongated grains. Cold working normally introduces surface residual tensile stresses. The presence of residual stress is corroborated by the sheet metal bulging and springing back at the region of cracking. The hard water in which the luminaires are immersed provide a conducive environment for stress corrosion cracking.

**Conclusion :** The luminaires have failed by stress corrosion cracking.

**Recommendations :** The following remedial measures were suggested to retrieve the manufactured components for further use and also to overcome the problem of cracking in future applications. (a) The finished components should be stress relief annealed at 260C-280C for 30 minutes. This will eliminate the residual stresses. For all future applications, components after deep drawing should be subjected to similar treatment. (b) Surface protection layers can be applied to the components in the form of some organic base waterproof paints.

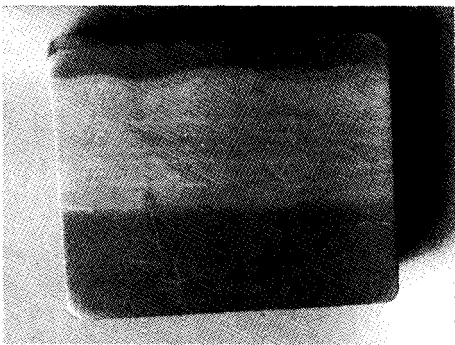
**Visual:** Fig 11 shows a cracked plate sent for investigation. All the cracks were at right angles to the weld (transverse cracks). Visually, the cracks were found to emanate from the base metal, close to the weld. Some of the cracks were through thickness and the cracks were of varying lengths. When some of these cracks were opened for further

Fig. 11. The cracked shell plate of a petroleum storage tank.

examination, it was seen that the fracture surfaces were discoloured by corrosion. Gross features of fracture were brittle in nature.

**Optical microscopy:** Microstructural studies on polished and etched sections showed a banded structure (alternate bands of ferrite and pearlite aligned in the rolling direction). The cracks were transverse to the rolling direction and the crack path was transgranular with little crack branching. Presence of gas porosity was also seen.

**Scanning microscopy:** Under the scanning microscope, cleavage fracture with feathery markings and isolated dimples was seen.

**Discussion :** Gross and microscopic features of fracture indicate brittle type of failure. Since the steel in question has a ductility of about 35%, brittle fracture is possible only when there is an embrittling agent. Fracture features like cleavage and feathery regions point to hydrogen as the embrittling species. In hydrogen cracking, also called cold cracking, the fracture is either intergranular or transgranular cleavage. Cold cracks are defects that form as the result of contamination by hydrogen. Whereas solidification cracking and heat affected zone (HAZ) cracking occur during or soon after the actual welding process, hydrogen cracking is usually a delayed phenomenon occurring days or weeks after the welding operation. Presence of thermal residual stresses can assist this process. Uniformity in hardness values rule out changes in microstructure as a contributing factor to the failure.

As reported, cracking is seen predominantly in the 20mm thick plates whose strength and hardness as determined is higher than test certificate values and also higher compared to the 18mm thick plates. It has to be noted that hydrogen cracking is strength sensitive, in that, the higher the strength of the metal, the more prone it is to hydrogen cracking. However, the primary cause for cracking in this case is the presence of hydrogen whose origin can be traced to several factors like improper weld surface preparation, improper storage of the welding electrodes, inadequate drying of the welding electrodes etc.

**Conclusion:** The shell plates of petroleum storage tank sent for investigation have undergone Hydrogen assisted cracking.

- (1) The cracked plates have to be rejected
- (2) For future welding applications, low hydrogen, dry electrodes should be used.
- (3) The weld surfaces should be dry and free from oil, grease, etc.

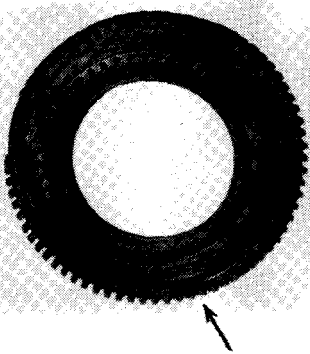
Fig. 12. The LPT blade locking plate region of the low pressure turbine disc.

**5.3.6 Discussion :** The above observations indicate that the center of focus is the LPT blade locking plate region since fractures/ damages in all the other components studied appear to be secondary in nature. It is probable that the first in the event of failure was the dislodgment of the LPT blade locking plate area from its position because of the shearing of the screws holding it under the centrifugal force of rotation and the blades thrust. Once the locking plate is not in position, it is possible for the adjacent dummy blades to slide out of their fir tree mountings and cause the other damages observed, including the jamming of the rotating mechanism leading to the breakage of the shaft.

**5.3.7 Conclusion :** It is probable that the LPT blade locking plate would have come out due to the shearing of the screws holding it in the outward direction. The dislodgment of the locking plate would have led to the further damages seen. The dislodgment can be attributed to factors related to non adherence to design drawings. The problem is aggravated by the lower strength of the screw.

- (1) Use of LPT blade locking plate of uniform thickness has to be reviewed in the light of design specifications which recommends a locking plate of variable thickness.

- (2) Confirm whether the studs (locking screws) and the locking plates have been heat treated to the required specifications.

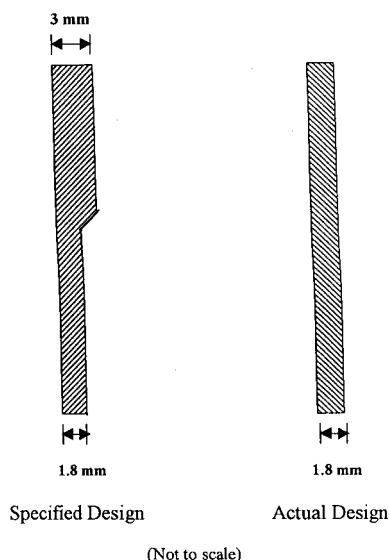
**5.3.5 Dimensional measurements and design discrepancies:** The lengths of the extracted screws (studs) were measured and found to be less than those of unused screws (studs). Similarly, some discrepancies were found in the design of the locking plate as compared to specifications. The locking plate used in this disk is of uniform thickness of 1.8mm whereas design specifies a thickness of 3mm over a width of 19.8mm

Fig. 13. The specified design and actual design of the locking plate.

and 1.8mm over the rest of the width (Fig.13). Drawing also specifies counter sinking on one side only while the actual plate was counter sunk on both sides.

An insight into the probable reason for the failure of the locking plate can be obtained by considering the locking plate design and also the strength of the screws used to hold it in position. It can be seen that the locking plate in the present case is of uniform thickness of 1.8mm whereas design specifies a thickness of 3mm over a width of 19.8mm and 1.8mm over the rest of the width. Drawing also specifies countersinking on one side only while the actual plate is counter sunk on both sides. The total length of the locking screw should be 10.5mm. The length of the hole drilled in the disc to accommodate the screw is 6.6mm. With this design, with a locking plate of 3mm thickness and a tab washer of 0.914mm thickness, it can be seen that the stud can be screwed in completely to hold the locking plate in position. However, when the locking plate is only 1.8mm thick, as is the case presently, a gap of 1.2mm is left. Since the screw was tightened completely, this gap was perhaps made up by grinding the bottom of the screw to this extent. The extracted screw (stud) did show grinding marks at its base to substantiate this observation. This means the plate is held effectively by a smaller length of screw. The locking plate of 1.8mm thick and counter sunk on both sides, had a bearing on the screws only to a thickness of 0.8mm which is also the pitch of the threads. Also, the hardness of the screw as measured is considerably lower than a new screw which in effect means lower strength. Since the fire was supposed to be for a short time and since the screw embedded inside the disc would not have come into direct contact with the fire, the reduction in hardness of the screw is unlikely to have been caused by the fire which was post failure.

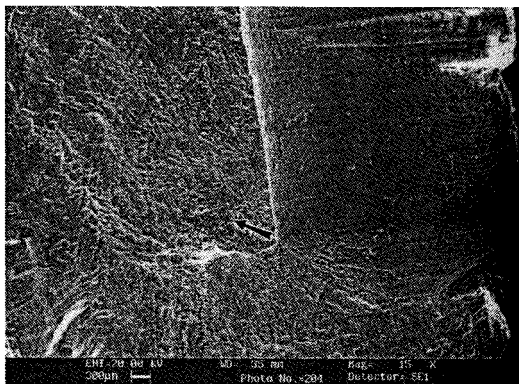
Fig. 15. The scanning fractograph of the fracture surface close to the threaded fastener hole undercut. Striations confirm fatigue fracture. Arrow indicates the direction of crack growth.

**Visual:** Fig 14 shows the cracked wheel hub received for investigation. Observations visually and under a stereo binocular microscope showed well defined half moon shaped regions, called beach marks, typical of fatigue at the top region of the hub. This suggests that the crack had initiated at the top region of the hub and progressed inward leading to final fracture near the base of the cylinder.

- (1) Inspect all the wheel hubs in aircrafts of this batch in the fastener hole regions for presence of cracks
- (2) Avoid excess tightening of the fastener

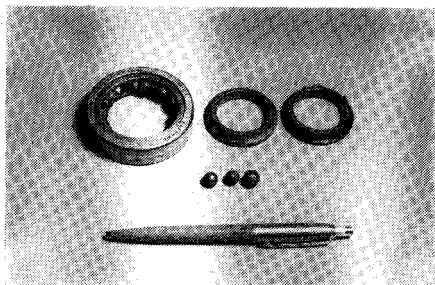
Fig. 16. The failed center support bearing of a jet engine.

**Hardness survey:** Hardness surveys were conducted on the inner and outer rings of the broken bearing as also on the balls. The hardness of the inner ring and the ball averaged RC 37 while that of the outer ring was RC 42.
